Manhole Inspection Summary

Manhole # S23UU1001MH

Insp Date: **11/30/06 10:15 AM**

Location Address: **211 EDGEVALE RD**

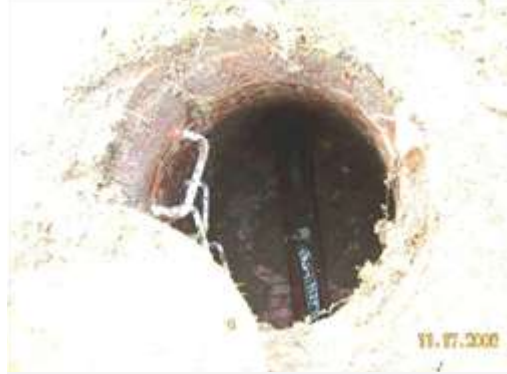
Top View

Frame offset. Evidence of surcharge - Bench debris. Channel debris.

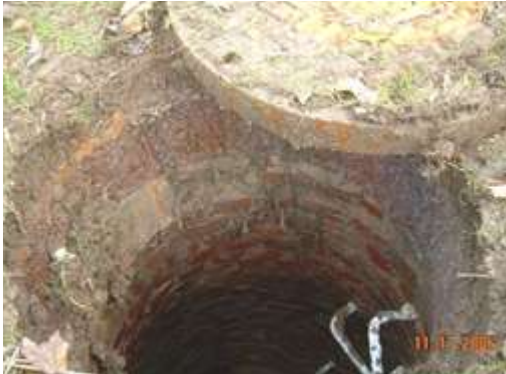
Defect

Adjustment root intrusion and infiltration. Barrel infiltration - other side.

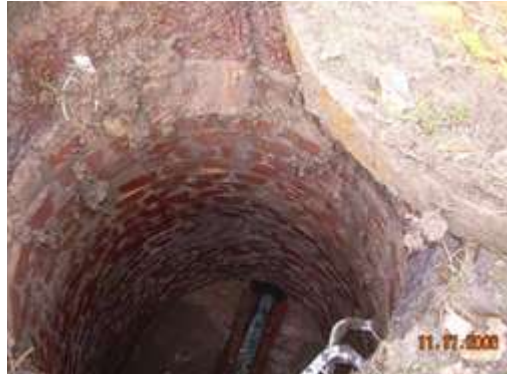
Defect

Adjustment root intrusion and infiltration. Barrel infiltration.

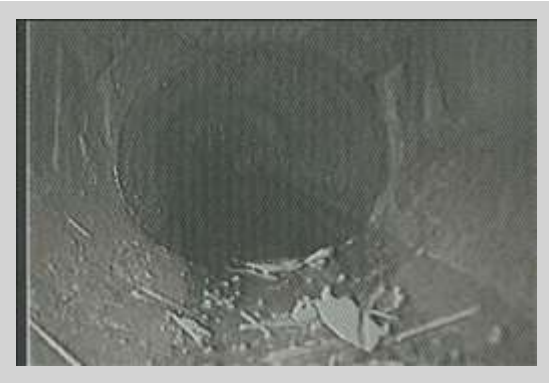
8 in. Circular Gravity Sewer Pipe Out @ 12 O'Clock

Infiltration: **Evidence** Pipe Seal Cond: **Cracked**

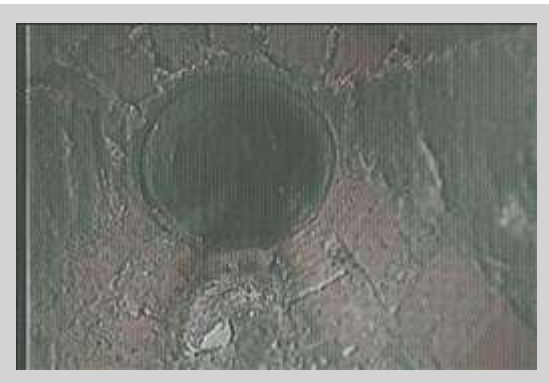
8 in. Circular Gravity Sewer Pipe In @ 6 O'Clock

Infiltration: **Evidence** Pipe Seal Cond: **Cracked**
